APPENDIX A: NORTH 27TH STREET CPTED REVIEW

In July of 2017, a block-by-block CPTED walk, between West State Street and West St. Paul Avenue, was conducted as part of the North 27th Street Corridor Strategy. The following summarizes some initial CPTED observations and recommendations for the North 27th Street commercial corridor.

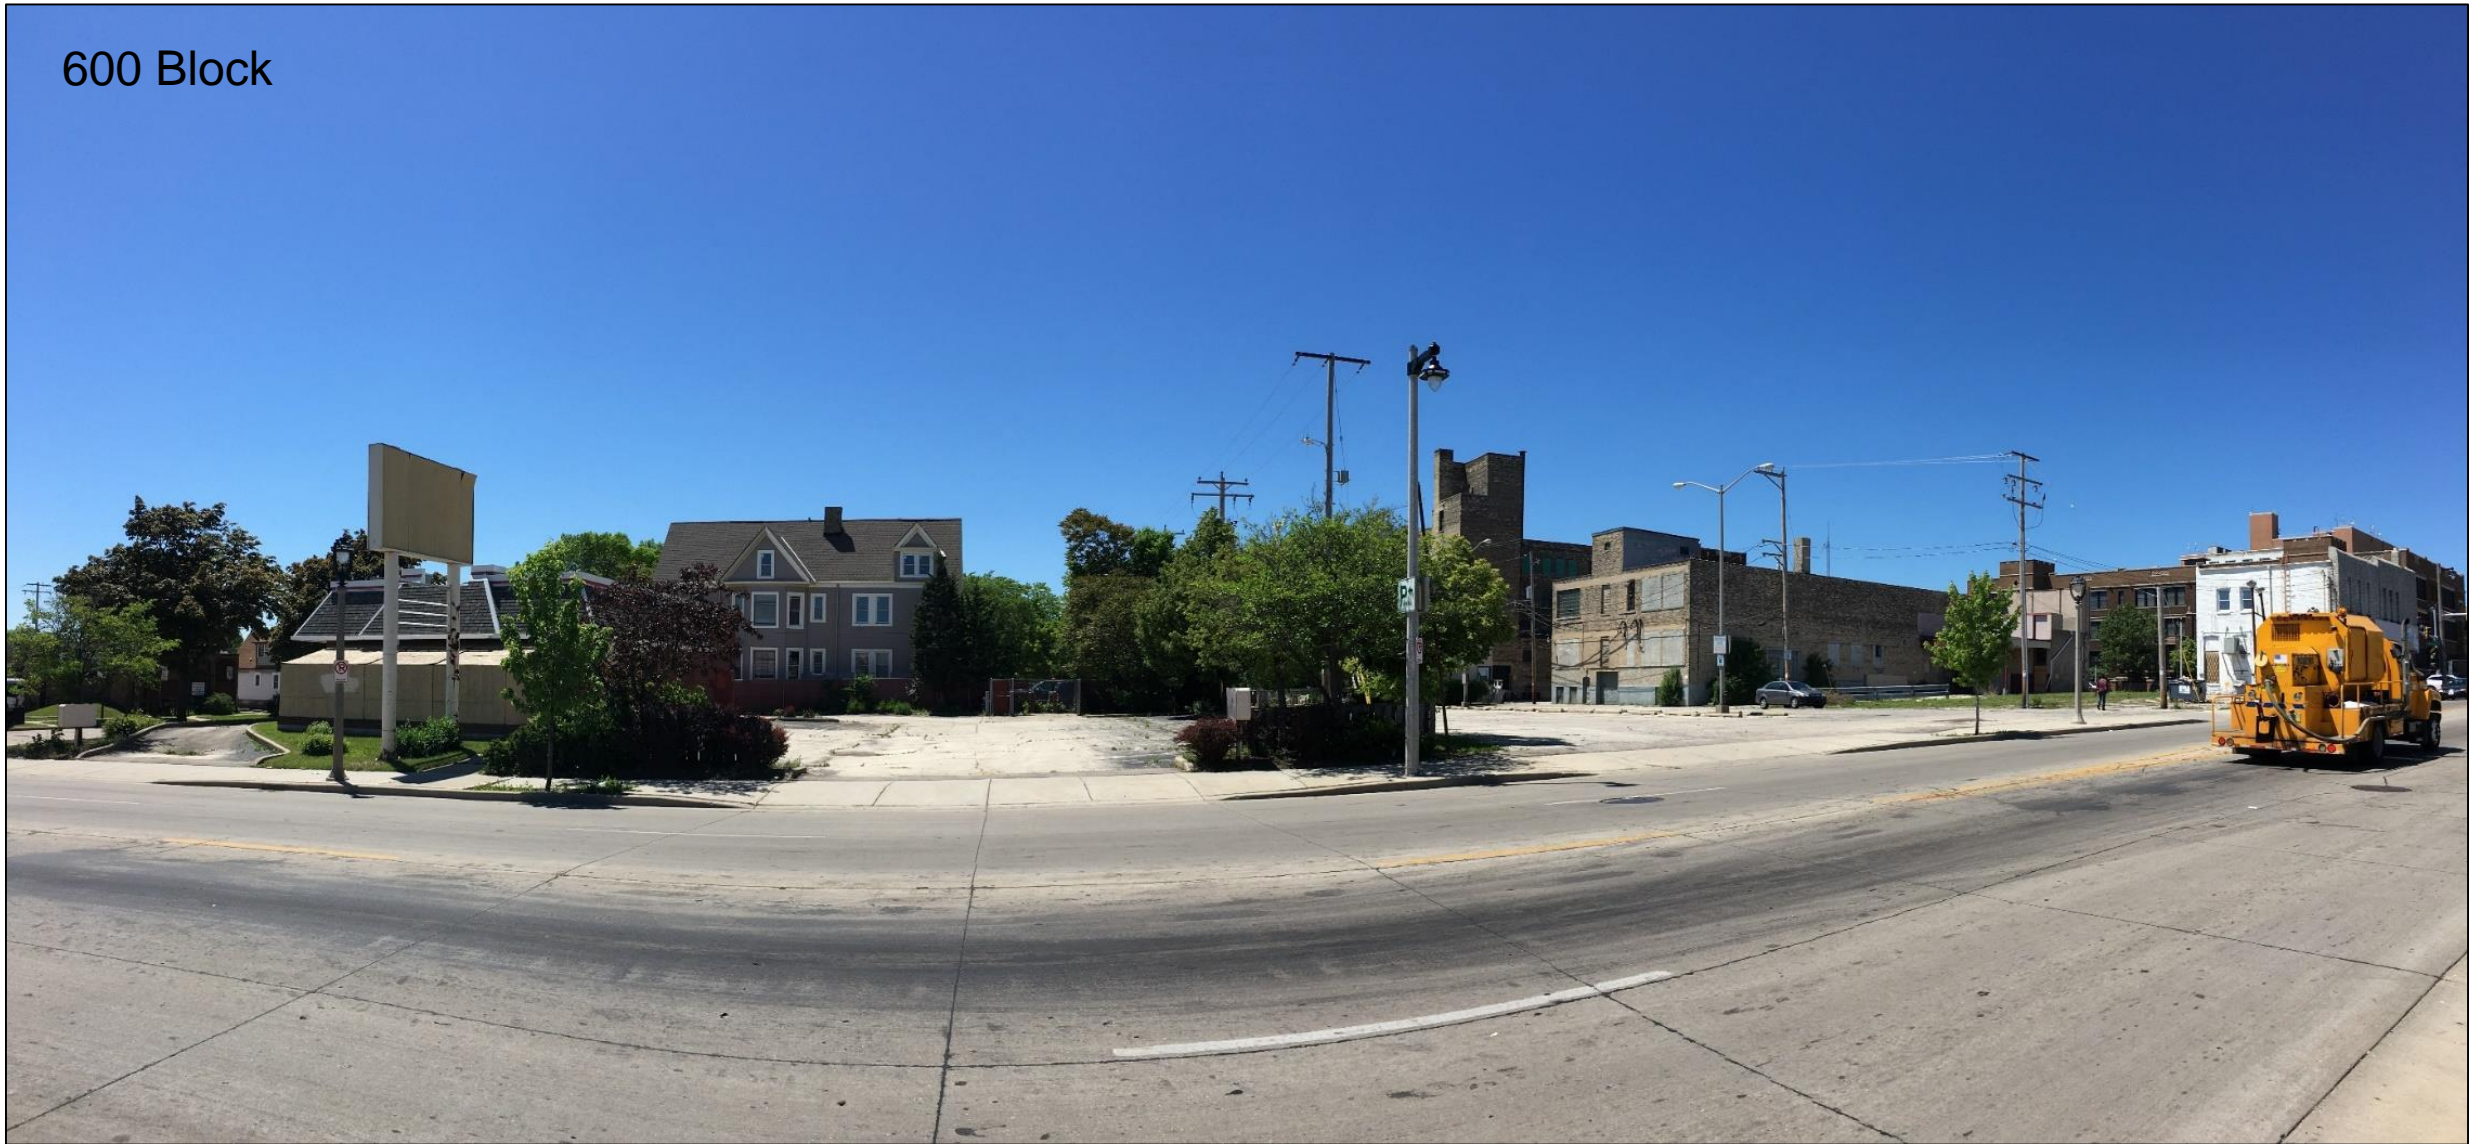
600 Block

- Primarily vacant block with multiple surface parking lots and curb cuts detracts from the public realm for an entire block length.
- Overgrown landscaping creates blind spots and poor sight lines decreasing safety and security.

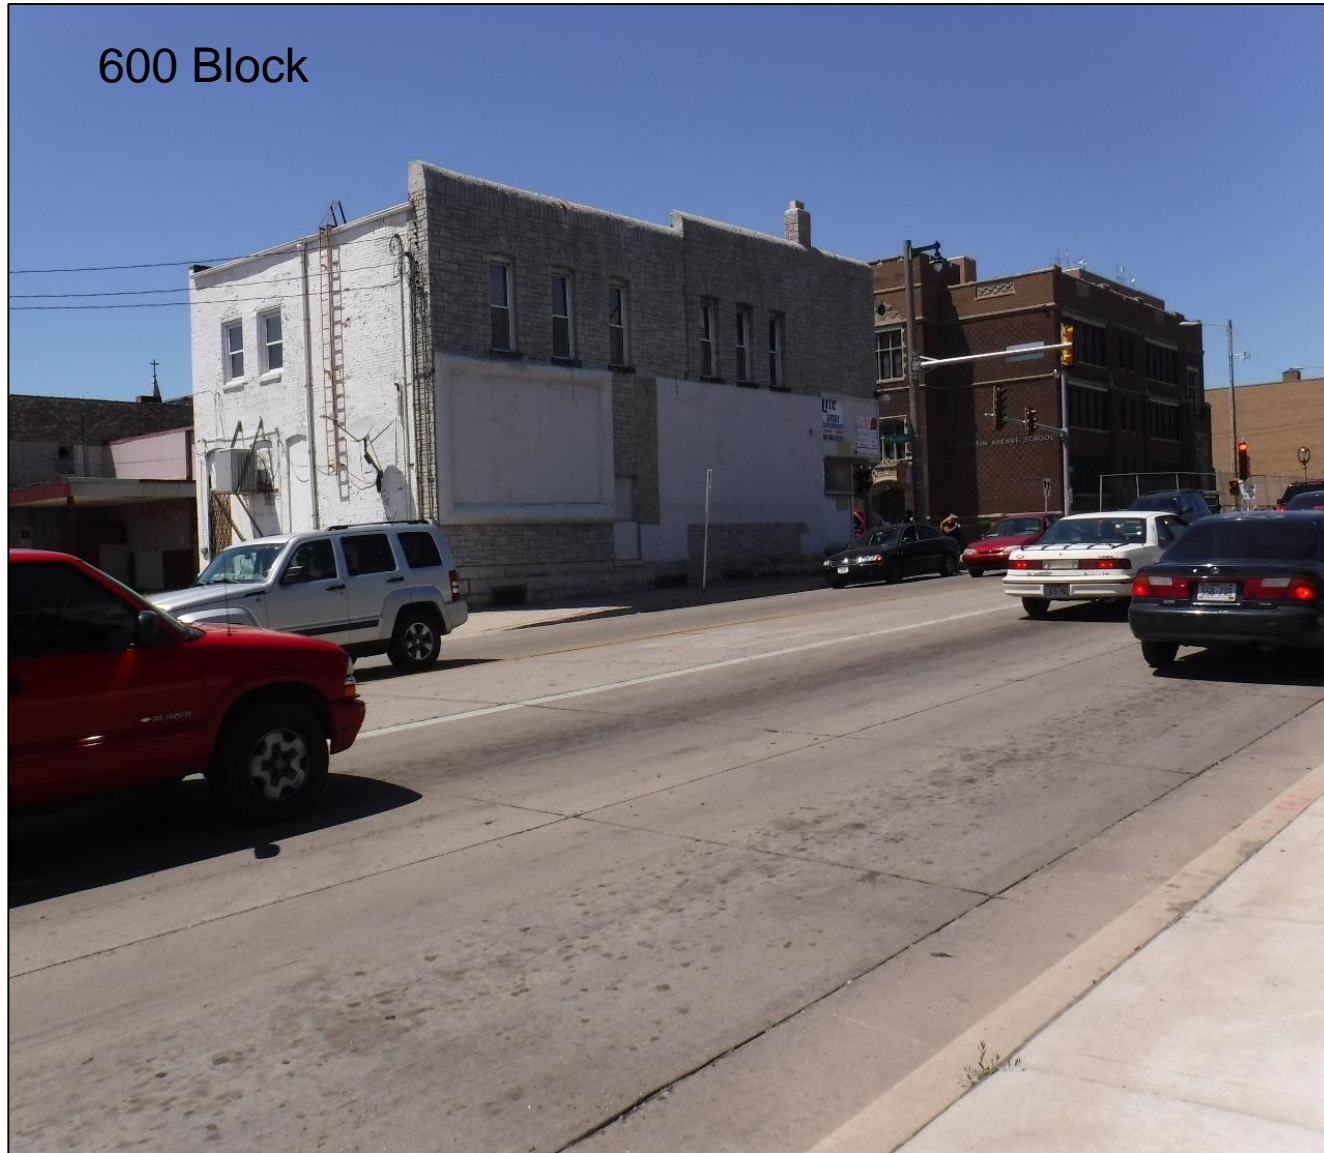
600 Block

- The exterior of the building is un-kept and gives the intersection a negative appearance.
- Front entrance is situated adjacent to a bus stop creating a pinch point on the sidewalk.

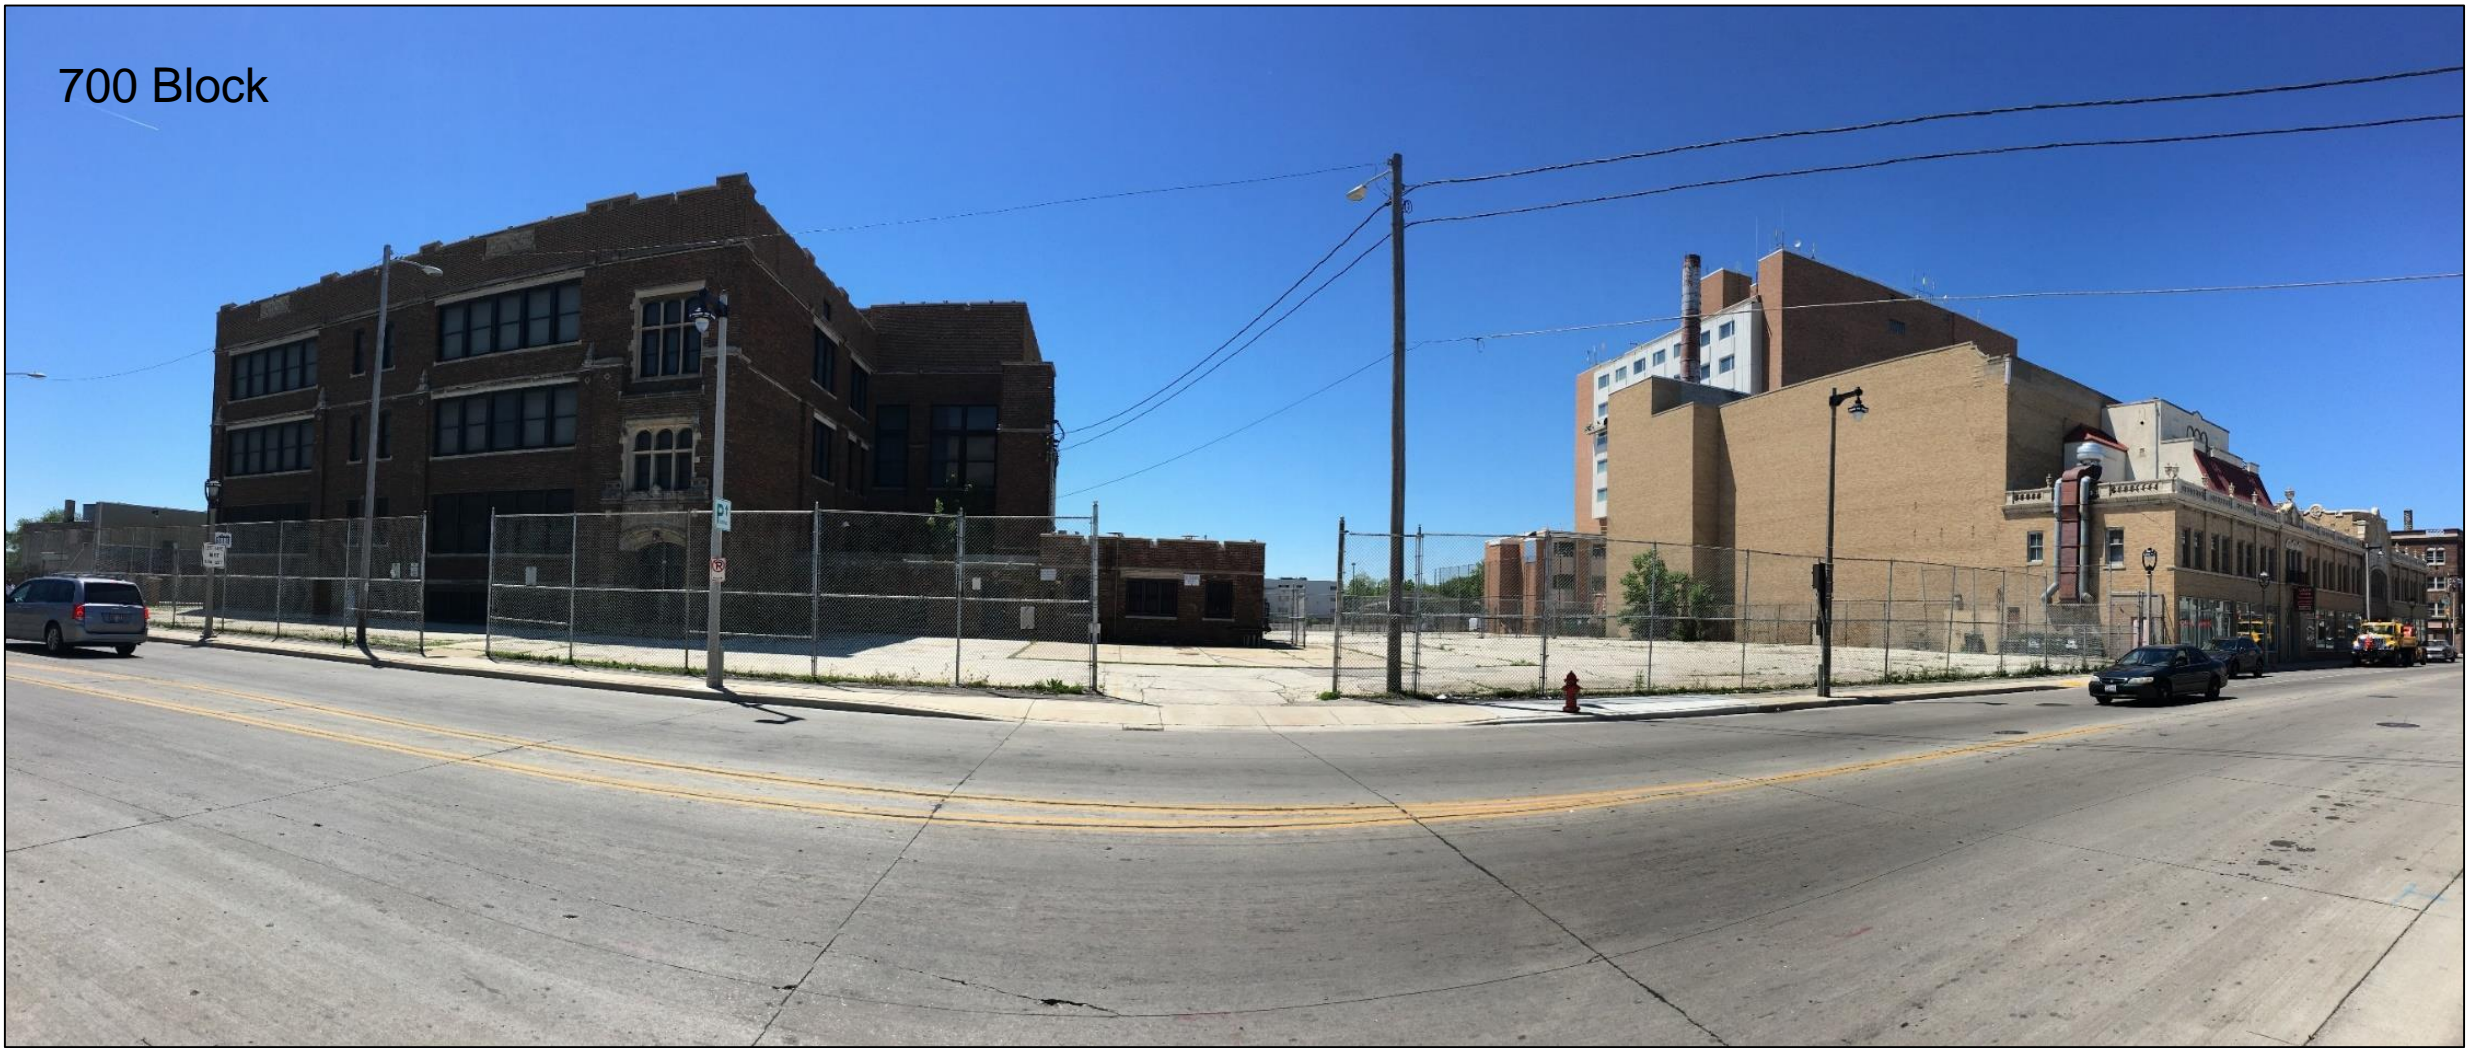
700 Block

- Future redevelopment efforts to improve security and pedestrian realm should focus on improved fencing and addition of perimeter landscaping to define property edge.
- LED lighting will illuminate open areas and sightlines and provide sense of security.

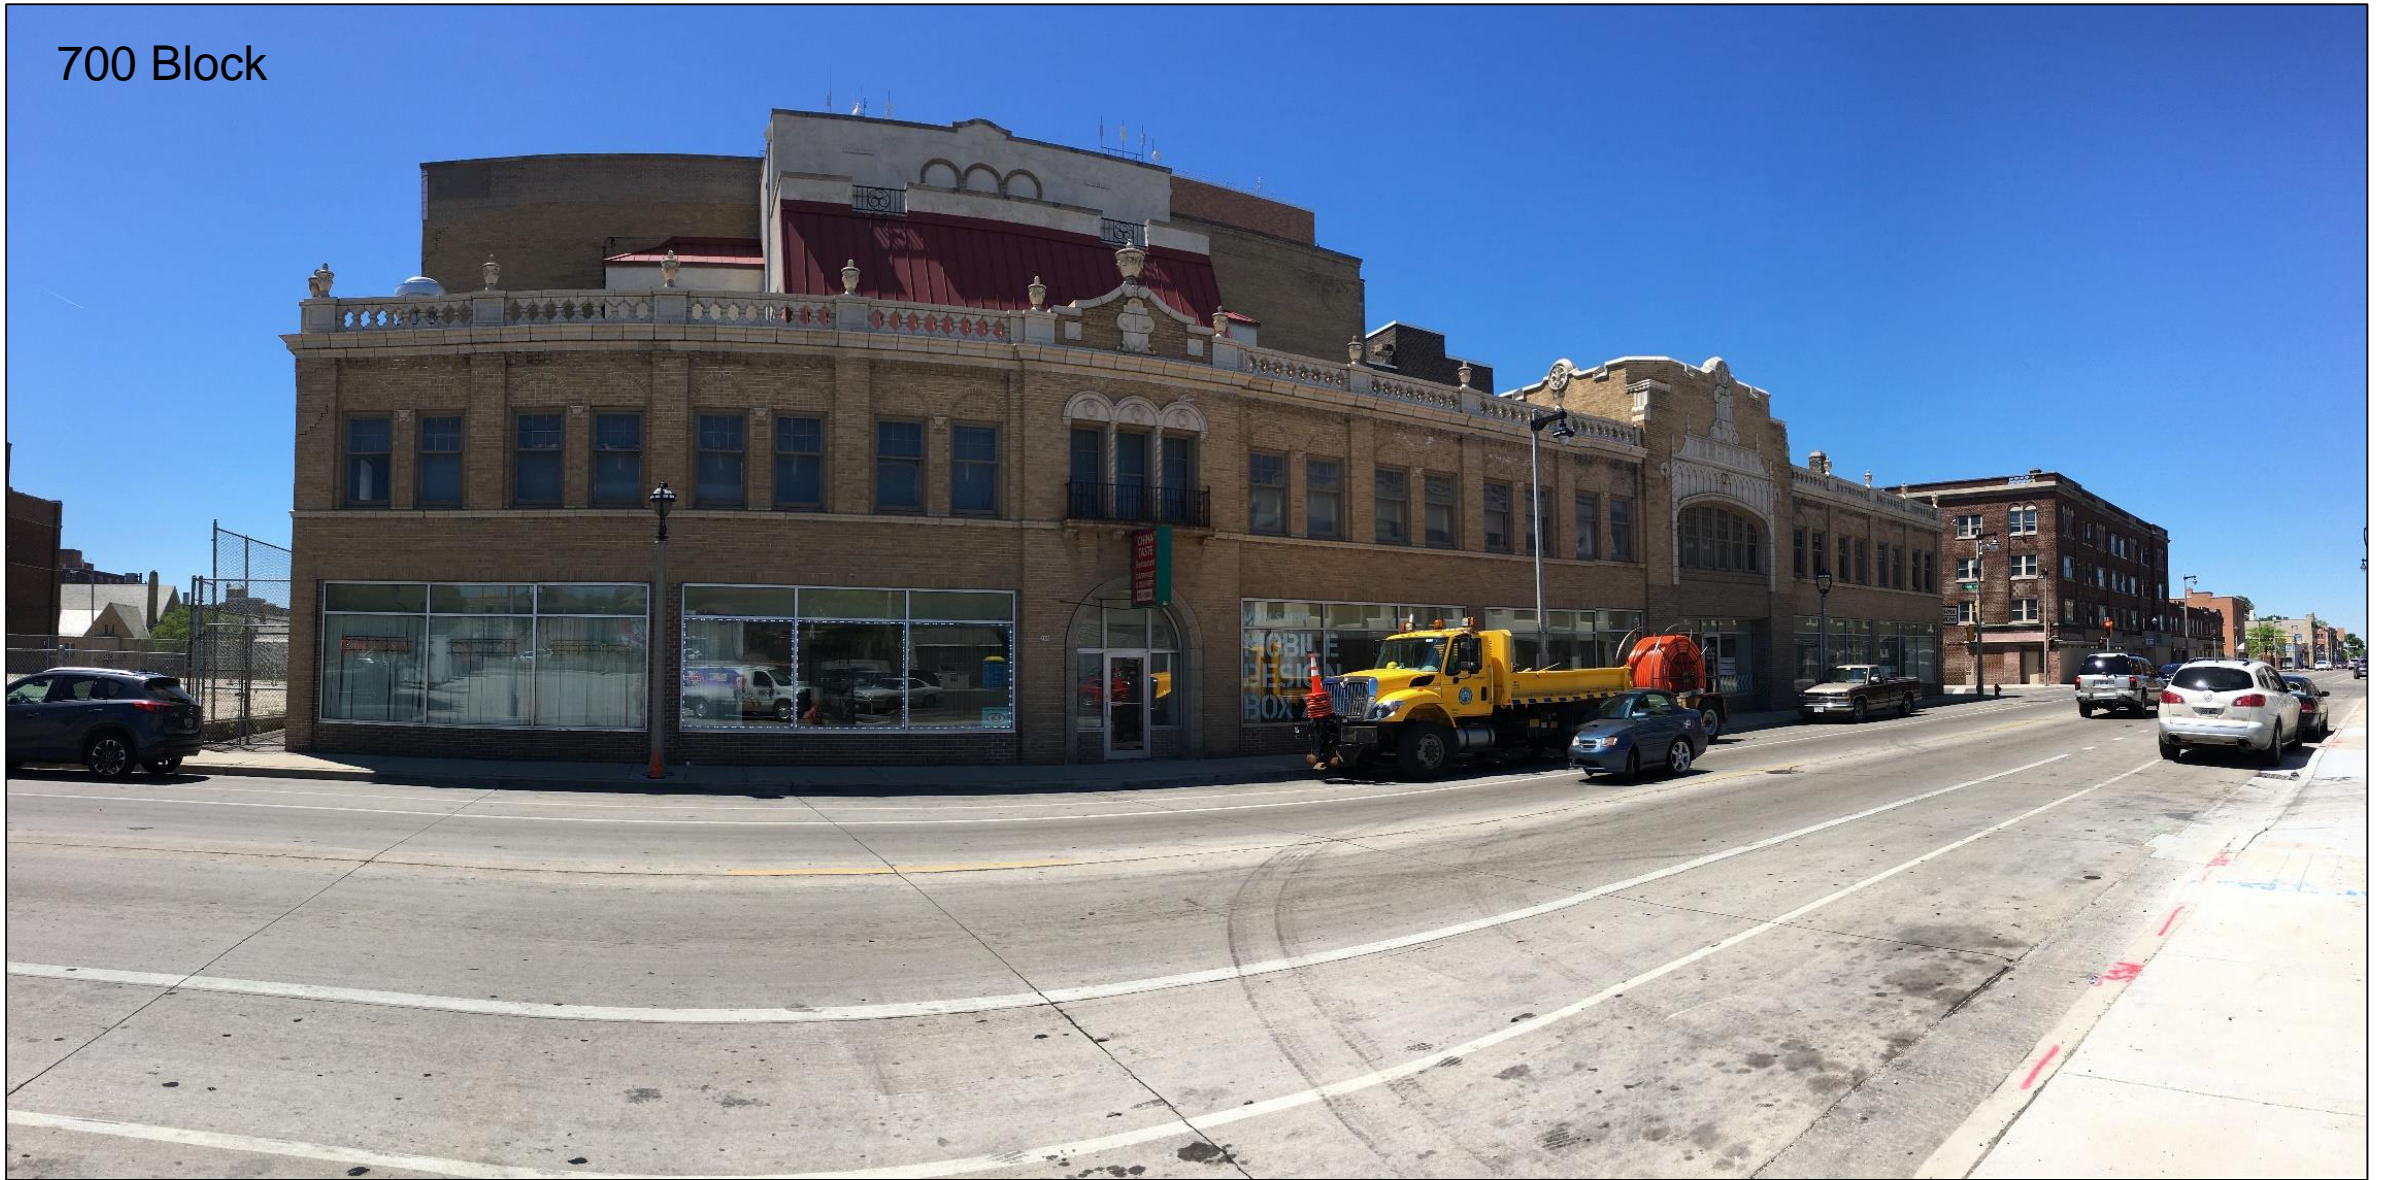
700 Block

- Future redevelopment should maintain the clear and uncluttered storefront window conditions.
- Prominent LED entry lighting should be incorporated with future tenanting.

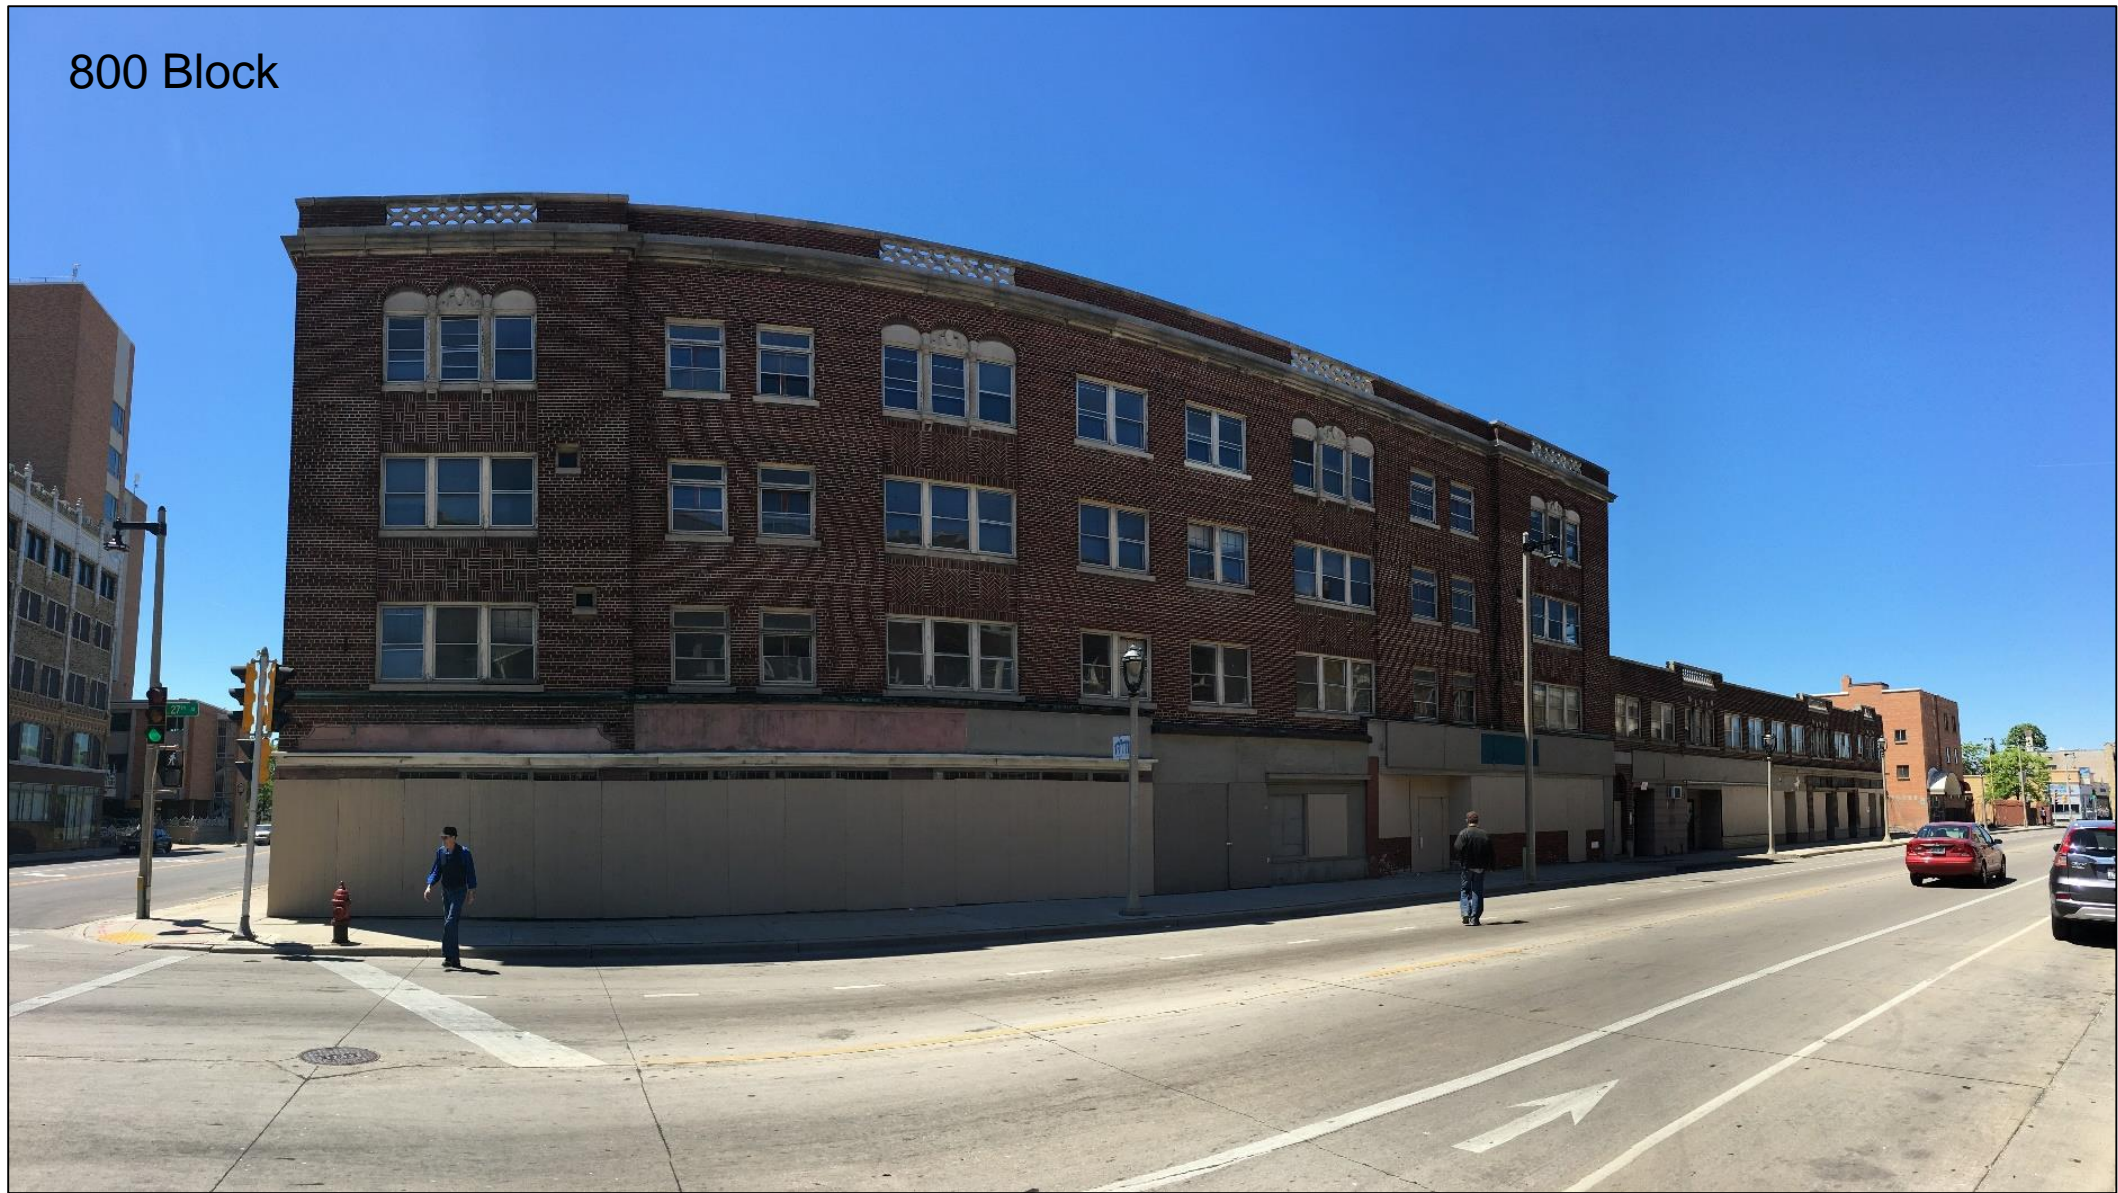
800 Block

- Up-lighting of upper floor façade can augment historic district designation and improve the street corridor.
- Short term actions to improve pedestrian comfort and safety can be the installation of entryway LED lighting.

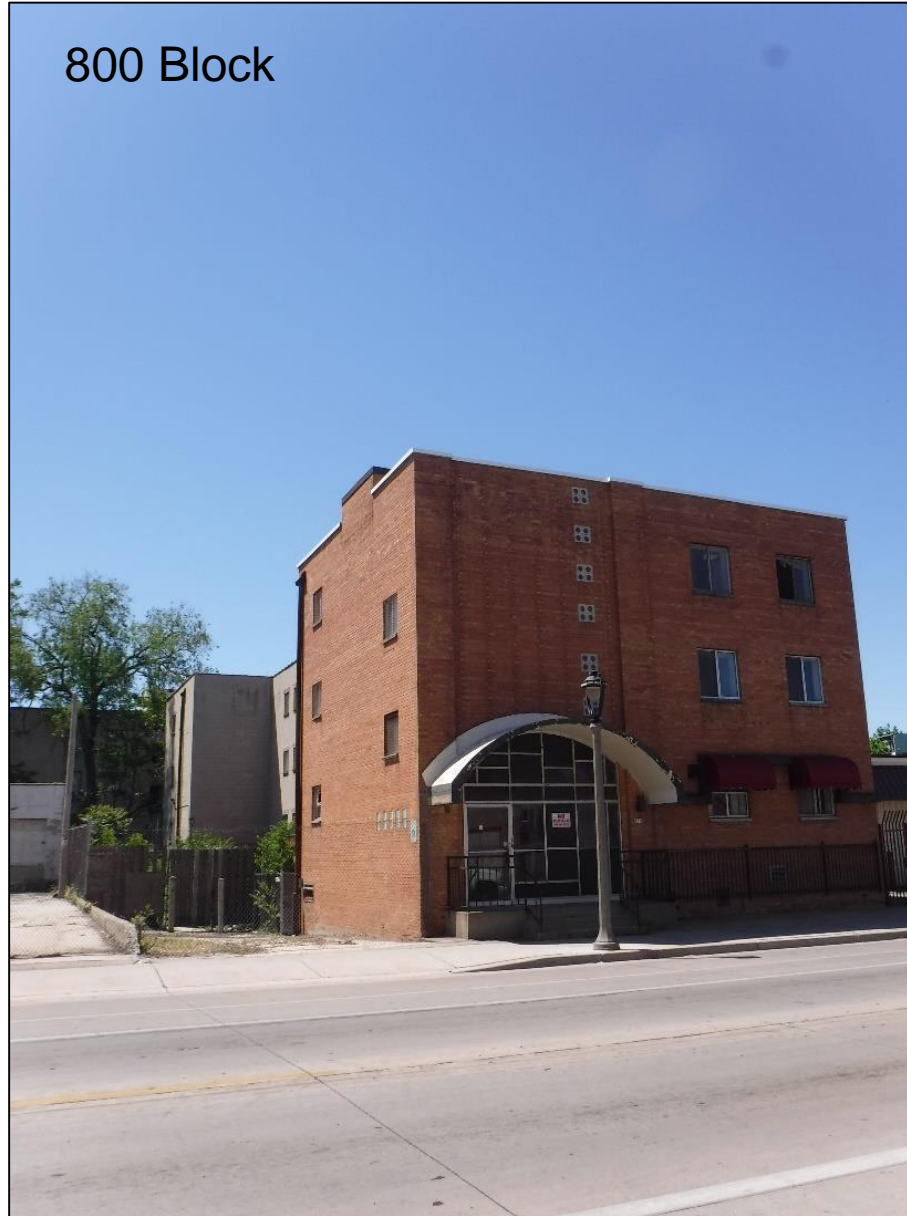
800 Block

- Ensure that the entryway is prominently illuminated with directional lighting and consider removing the rear shrubs to eliminate blind spots.

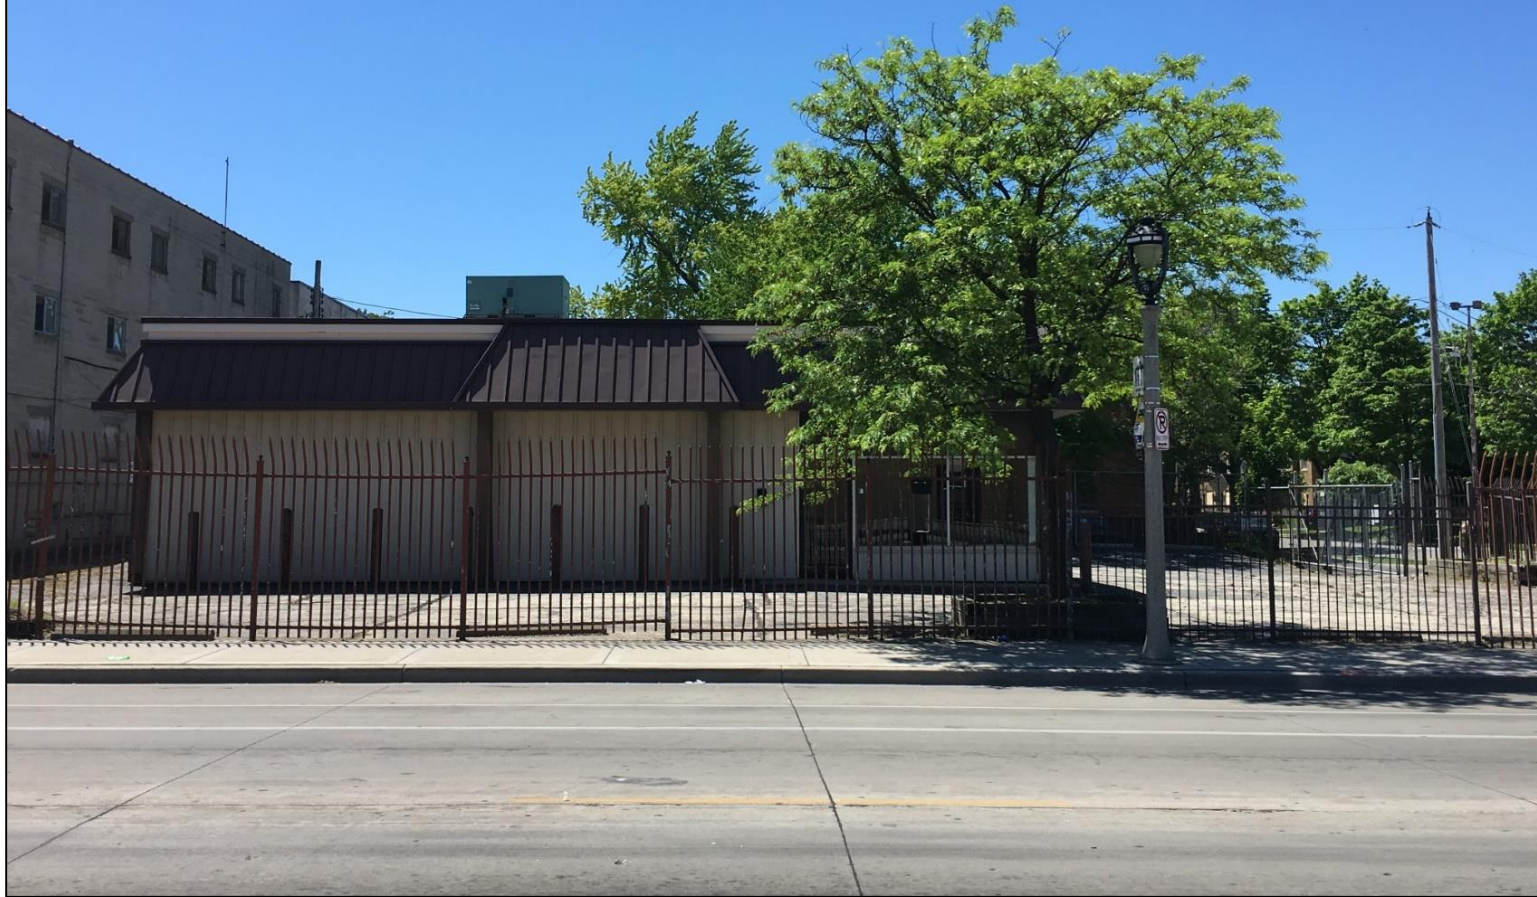
800 Block

- Sidewalk light coverage is diffused by tree canopy creating blind spots.
- Future redevelopment of site should incorporate parking lot perimeter landscaping and prominent lighting to provide security and eliminate dark zones.

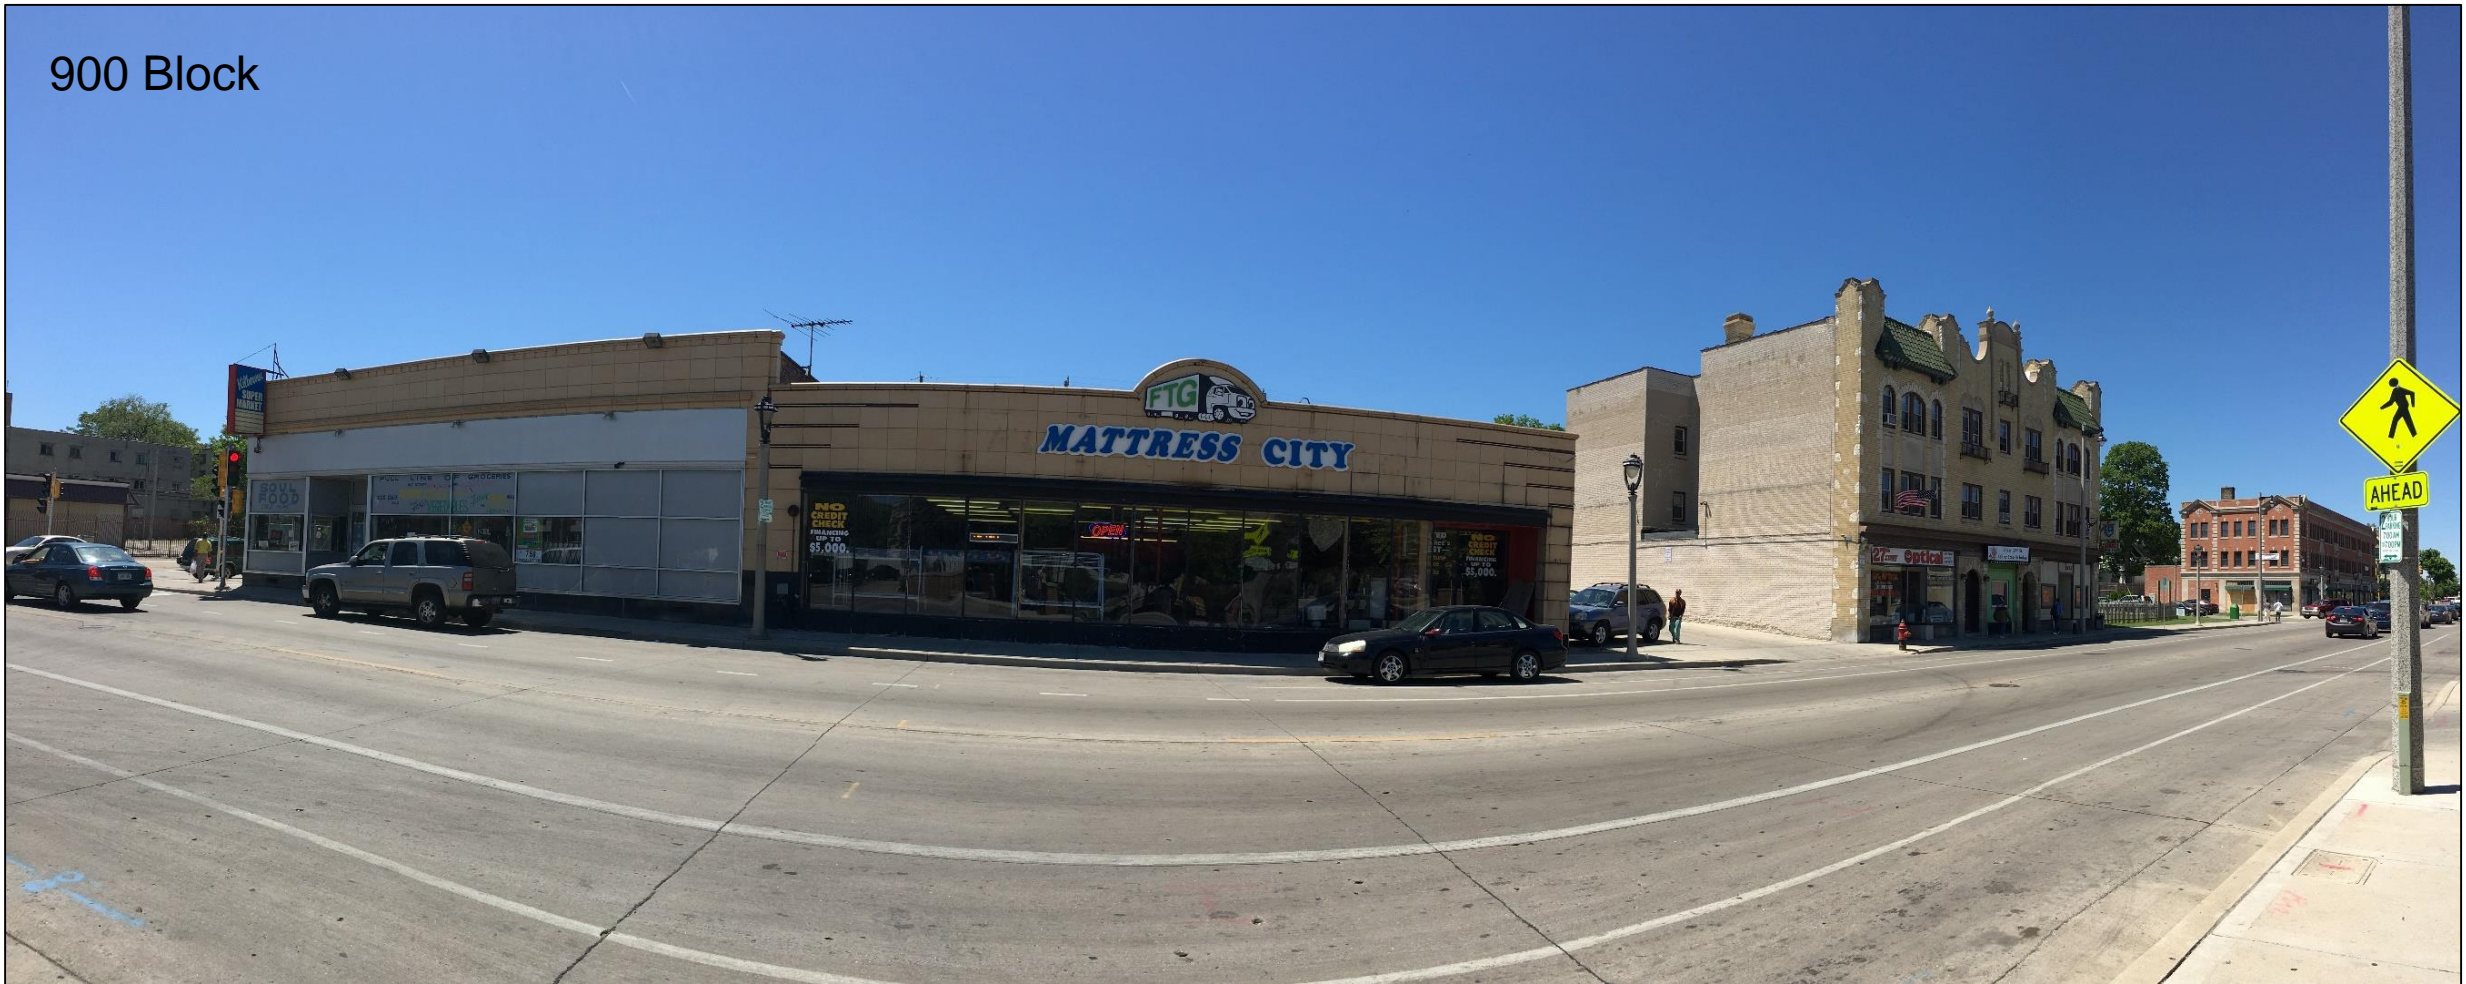
900 Block

- Where feasible market should continue efforts to open up front façade to improve public realm and a more welcoming entry. Property is a good candidate for façade grant consideration.
- Recommend improved lighting at Mattress City entryway.

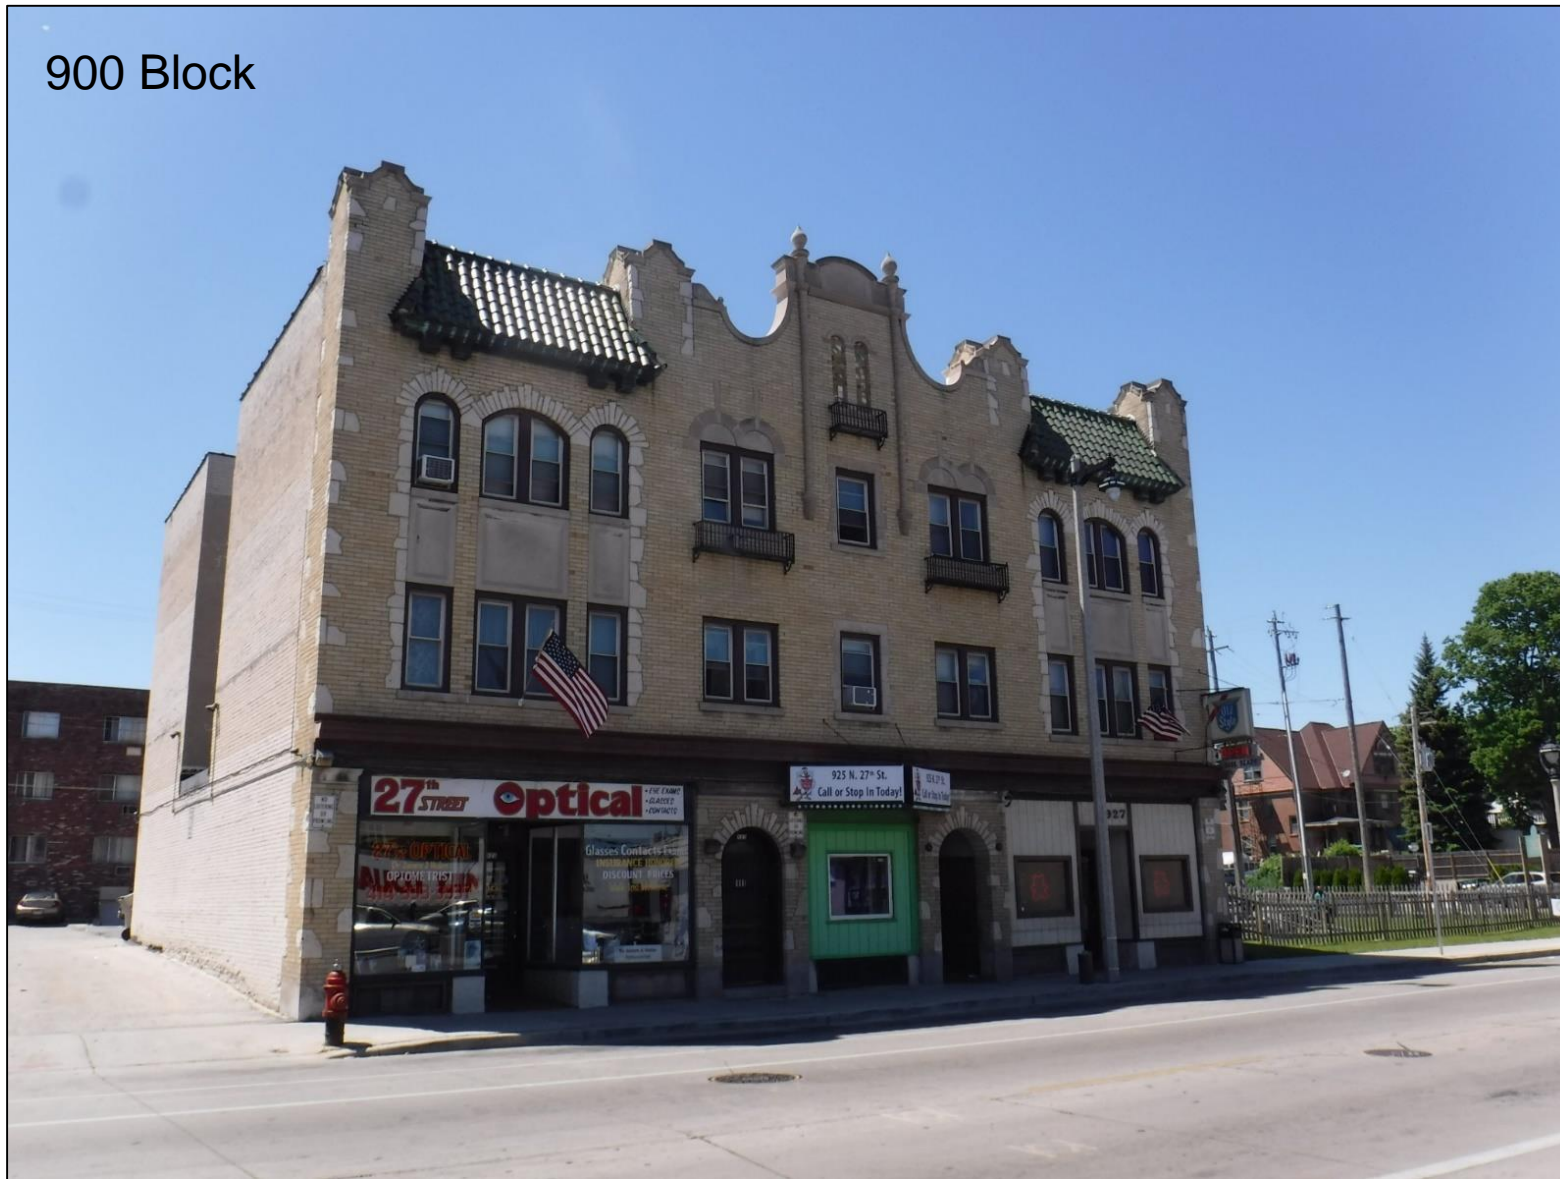
900 Block

- Entryways are clean and maintained but recommend improved lighting.
- Tavern and Milwaukee Liquor spaces would benefit from improved façades for more inviting public realm and eyes on street.

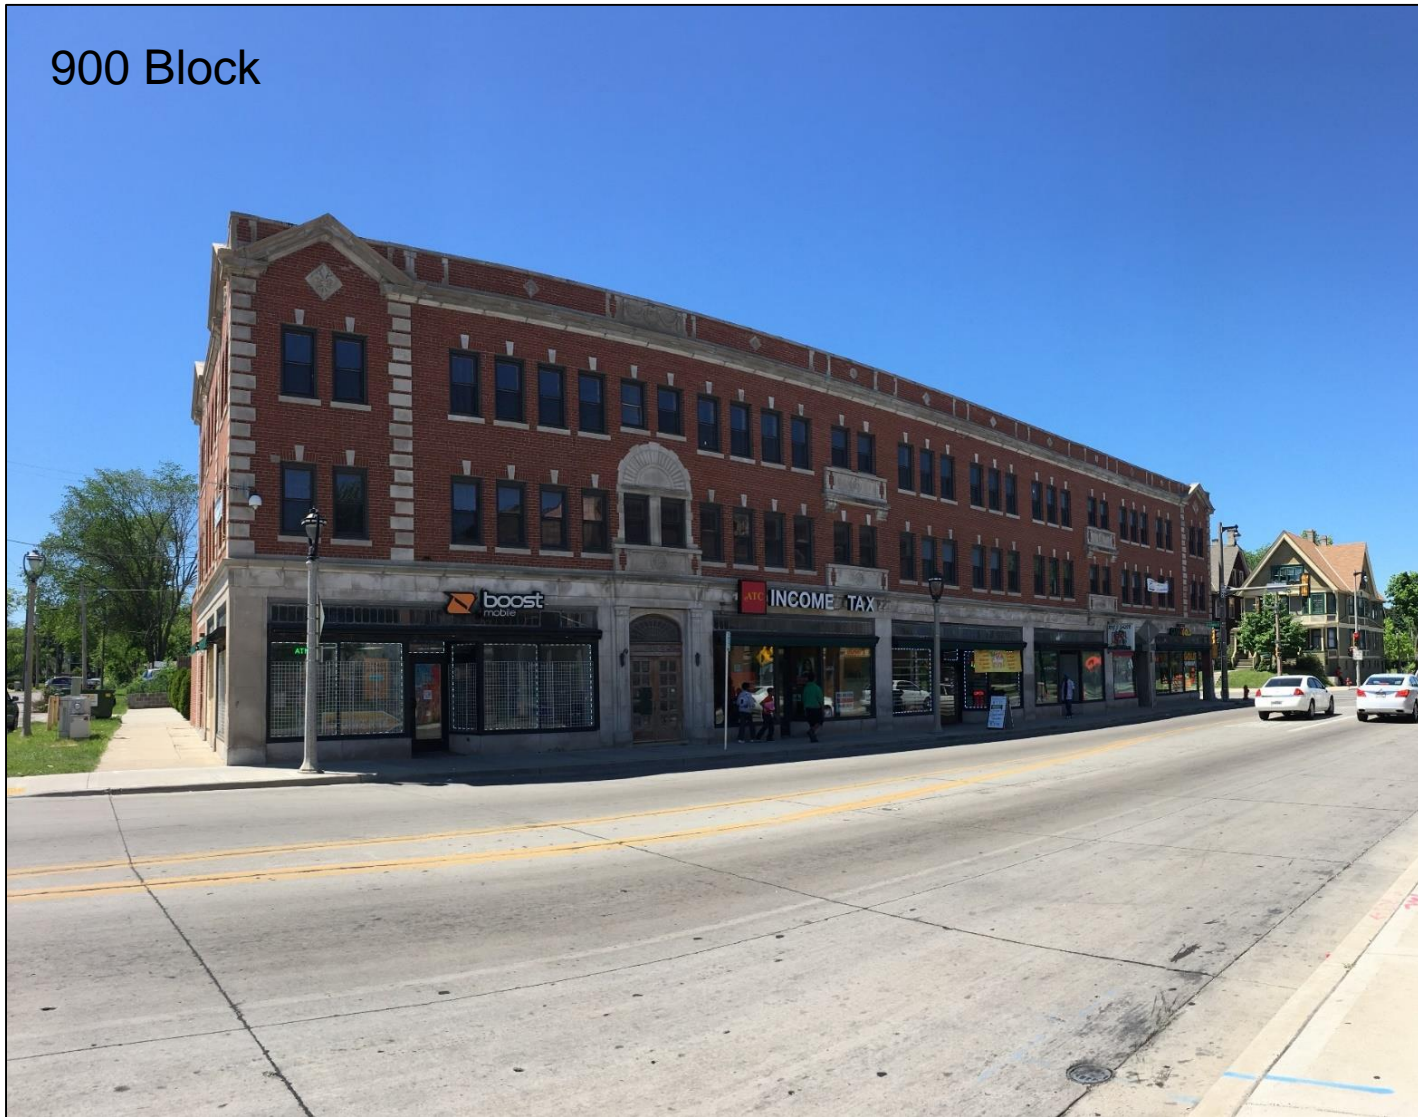
900 Block

- Rope lighting, while permitted, should be reconsidered.
- Minimal lighting along front of building creates dark spots.
- Fixtures at entrance to upper floors lack light bulbs; lighting at this entrance should be prominent to create a sense of comfort for tenants and visitors.
